State of Utah DEPARTMENT OF NATURAL RESOURCES Division of Oil, Gas & Mining

Inspection Report Minerals Regulatory Program June 17, 2013

Mine Name: Reef Mine	Permit Number: S/015/0094	
Operator Name: Castle Valley Stone	Inspection Date: June 11, 2013	
Inspector(s): Wayne Western, Mike Bradely	Time: 12:25 – 1:15 pm	
Other Participants: none	Mine Status: ACT	
Weather Condition: Clear sky 77 degrees	Last Inspection: June 18, 2013	
Bond Renewal Date: August 3, 2012	Bond Amount: \$25,200.00	
Surface Ownership: SITLA	Mineral Ownership: SITLA	
Last Year of Production: 2011 annual report for 2012 NA	Acreage: 5 acres

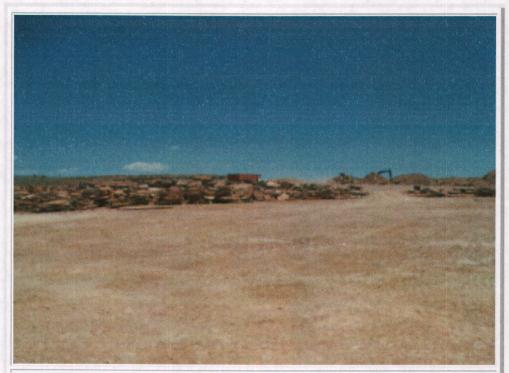
Stockpiles and loading area.

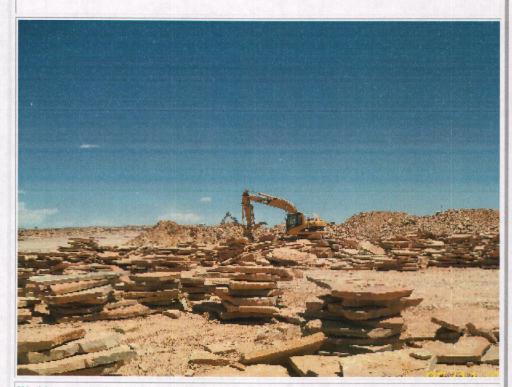
Working areas and storage

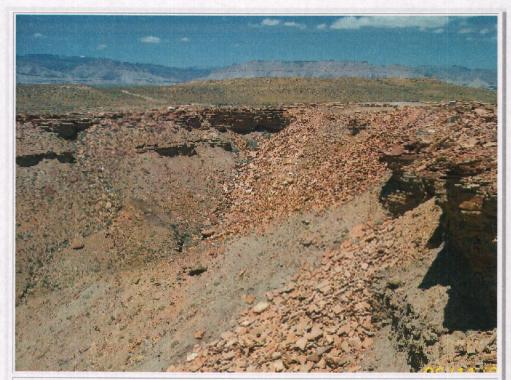
Overburden was placed in drainages along the edge of the disturbed areas.

Waste material pushed into drainage

The Division will issue a cessation order until the issue of mining outside the permit boundary has been resolved.

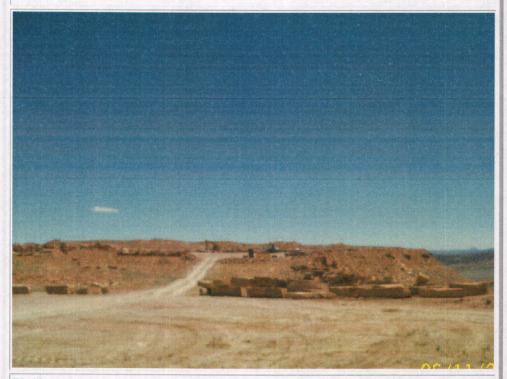
Working areas
